Technical Bulletin

Mazda RX8 – Expansion Tank Coolant Level

Applicable References: ADM59860

Applications: Mazda RX8

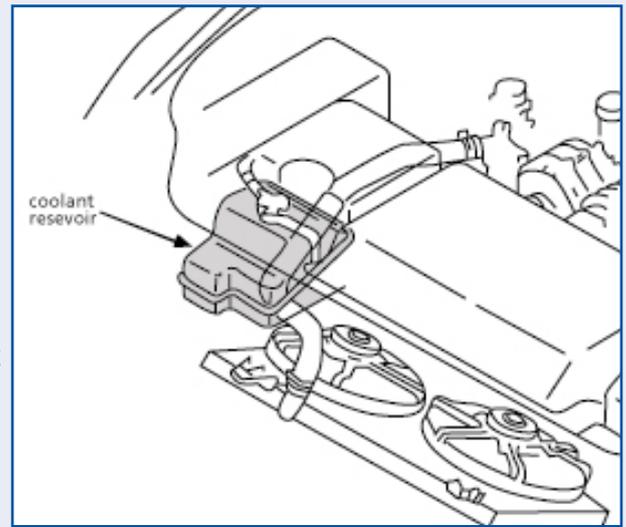
The coolant level sensor float is a common failing part on the Mazda RX8.

This is caused by surface deterioration of the sensor float which allows it to absorb coolant, causing the float to sink and give a false reading.

The coolant level light on the dashboard either stays on or flashes indicating a low coolant level, even when the coolant level is actually correct.

The sensor and float are not available separately, meaning the only permanent repair is to replace the complete Expansion Tank assembly.

Blue Print now supplies an OEM quality **Expansion Tank** with a revised specification coolant level sensor float – **ADM59860** – which is covered by Blue Print's comprehensive Three Year Warranty.
