CRUISE CONTROL SYSTEM

1983 Mazda RX7

1983 CRUISE CONTROL SYSTEMS

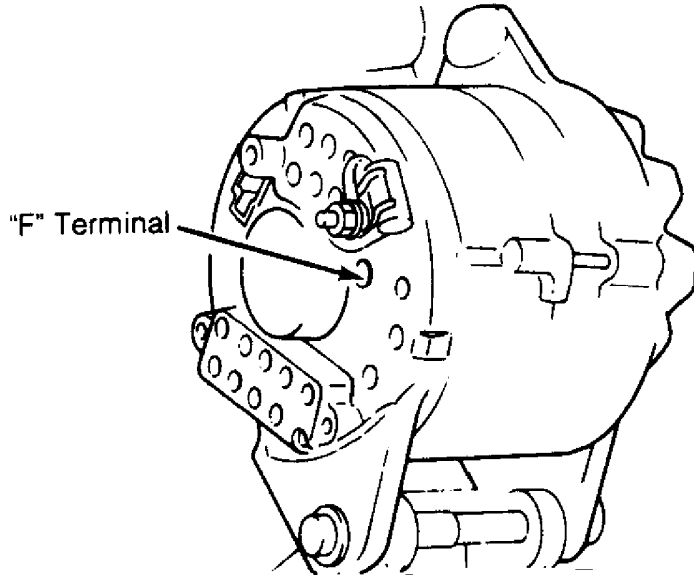
29386

Fig. 1: Alternator "F" Terminal Location
Terminal is located .8" (20 mm) below the hole.

4) Read the voltage at "L" with "F" terminal shorted. If voltage is lower than battery voltage, regulator is defective. If voltage is close to battery voltage, alternator is defective.

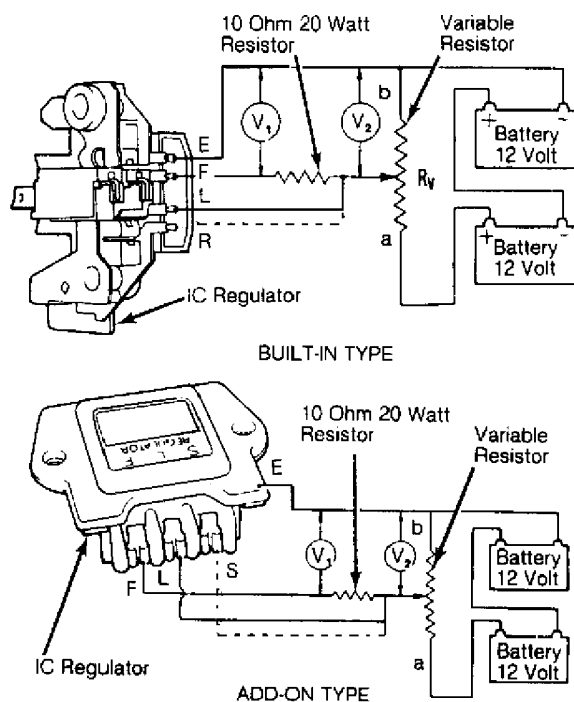
29388

Fig. 3: Testing Mitsubishi Integral Regulator

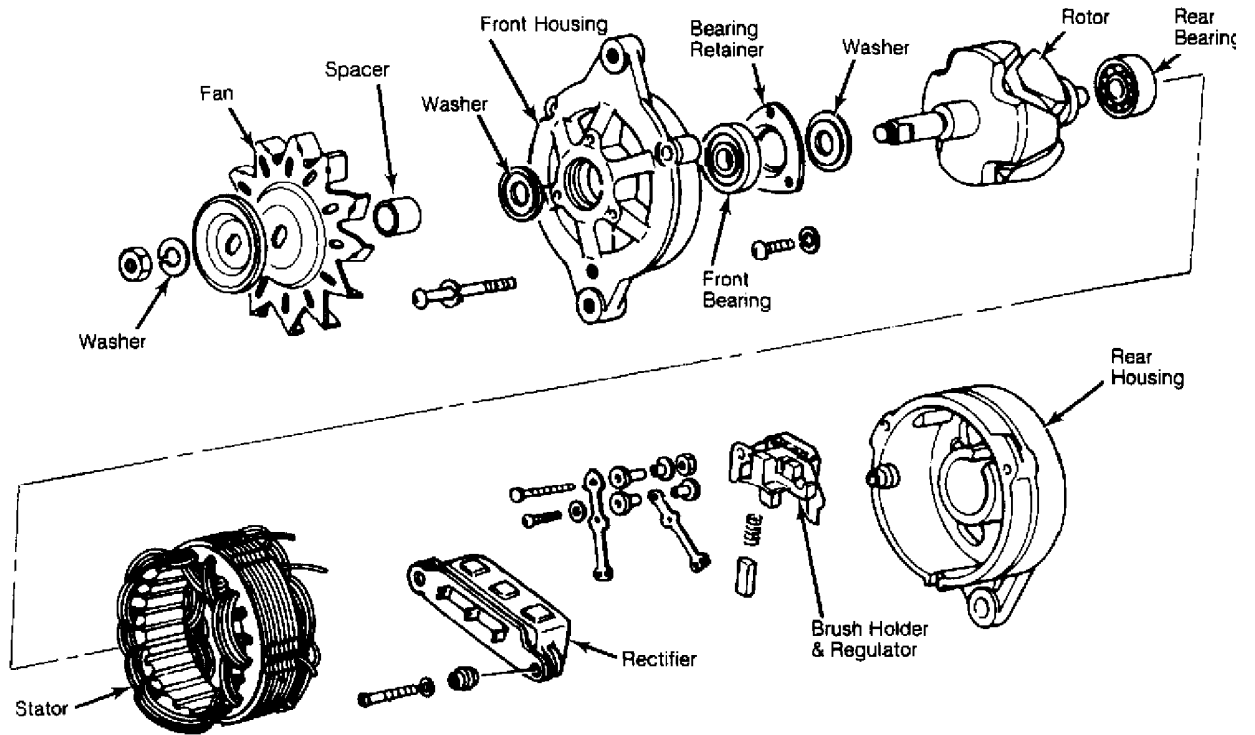
29389

Fig. 4: Exploded View of Mitsubishi Alternator

Reassemble by reversing disassembly procedures. Soldering of rectifier leads should be done in less than 5 seconds to prevent damage to diodes. When installing the rotor assembly in the rear housing, hold the brushes in position by inserting a stiff piece of wire into the access hole in rear housing.

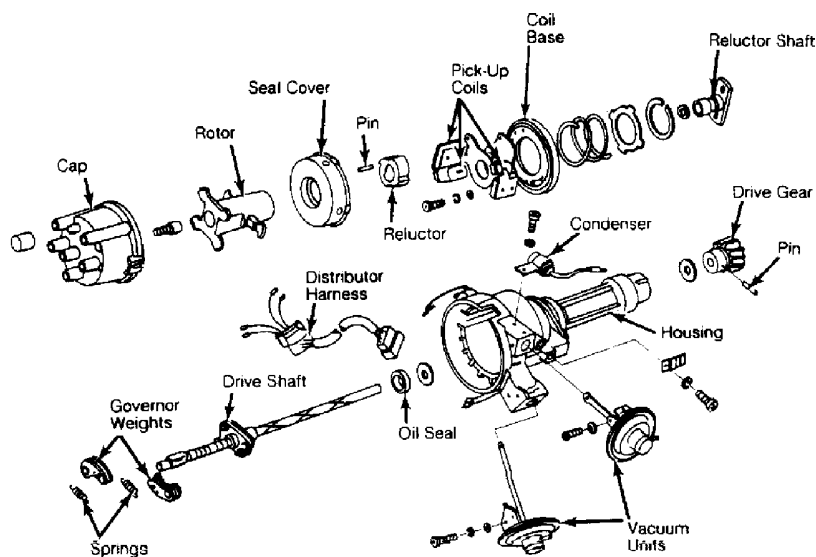
29017

Fig. 6: Disassembled View of RX7 Mitsubishi Distributor

2) Assemble distributor in reverse order of disassembly, noting the following: Install reluctor shaft onto distributor drive shaft, engaging slots of reluctor shaft and governor pins. Install pick-up coil and coil base bearing assembly and tighten attaching screws. Install reluctor on shaft, driving spring pin in with a punch.

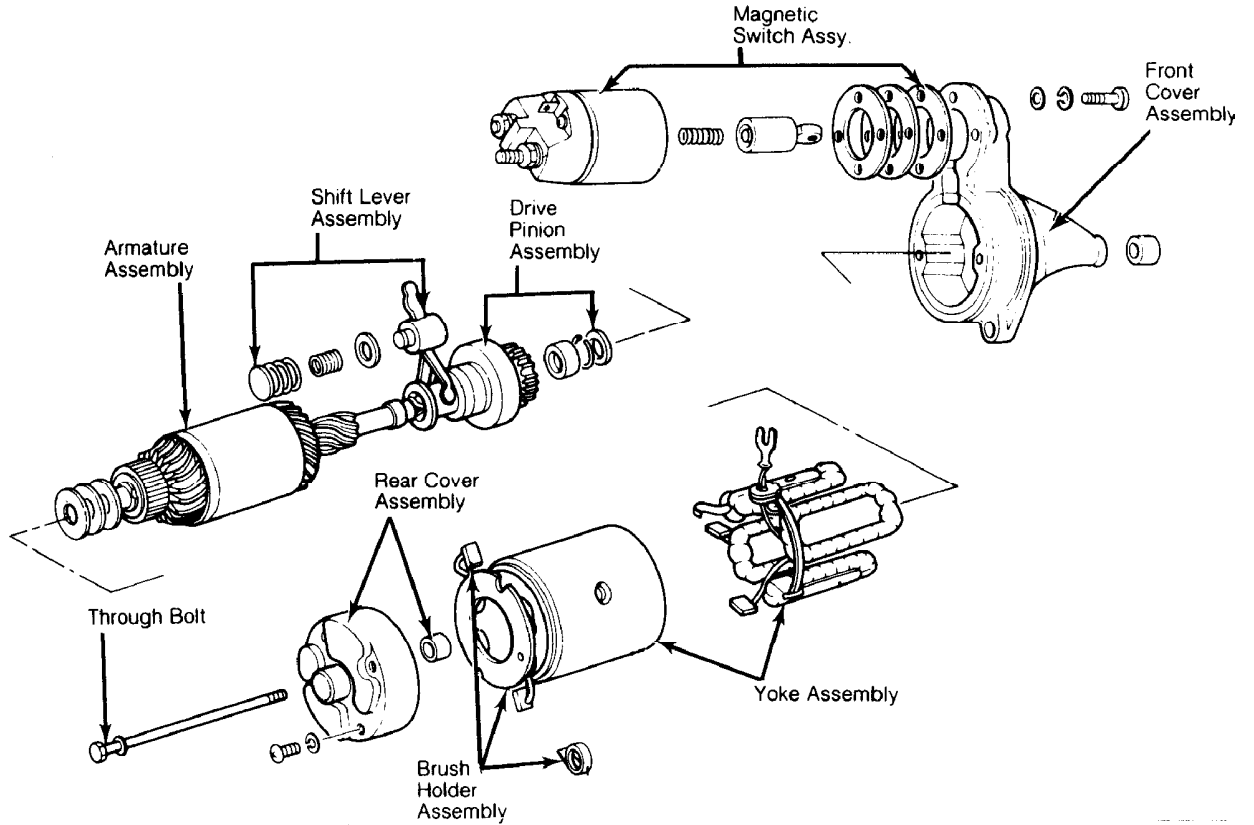
29420

Fig. 5: Disassembled View of Typical Mitsubishi Conventional Starter

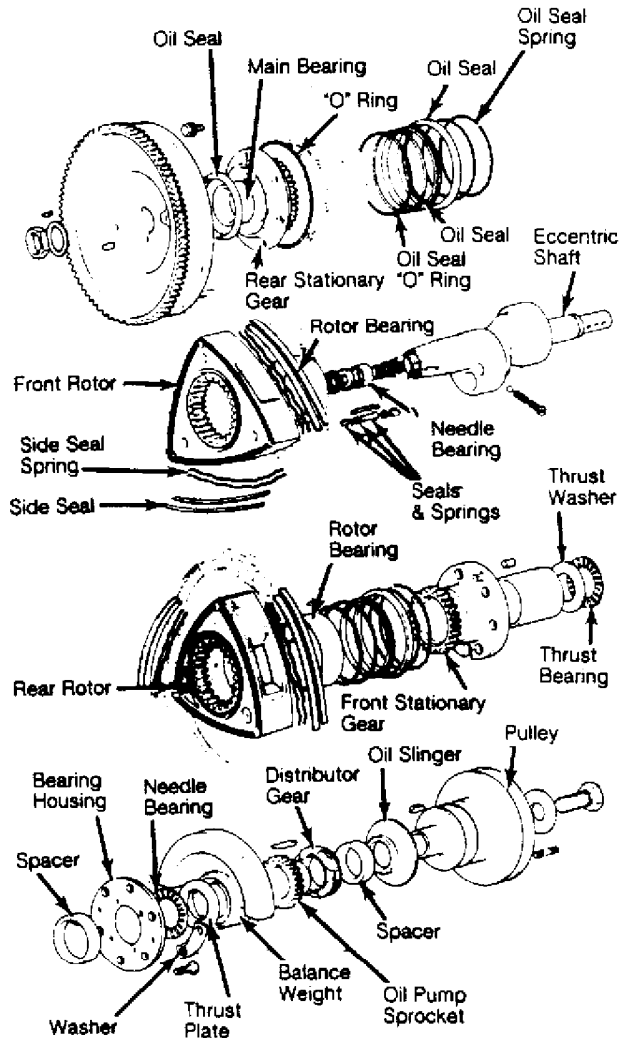
Fig. 1: Exploded View of Rotors & Eccentric Shaft Assembly

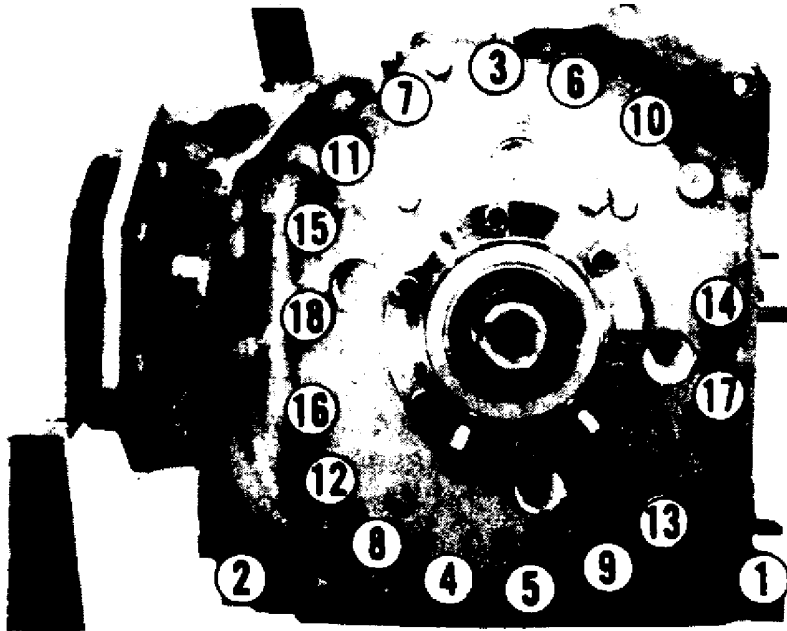
Fig. 3: Loosening Sequence of Tension Bolts
Loosen in 2 or 3 steps.

7) Remove tension bolts on rear housing in sequence. See Fig. 3. Loosen in 2 or 3 steps. Lift rear housing off shaft. Remove any seals stuck to rotor sliding surface, and place them back in original positions. Remove seals and "O" rings from face of rear rotor housing.

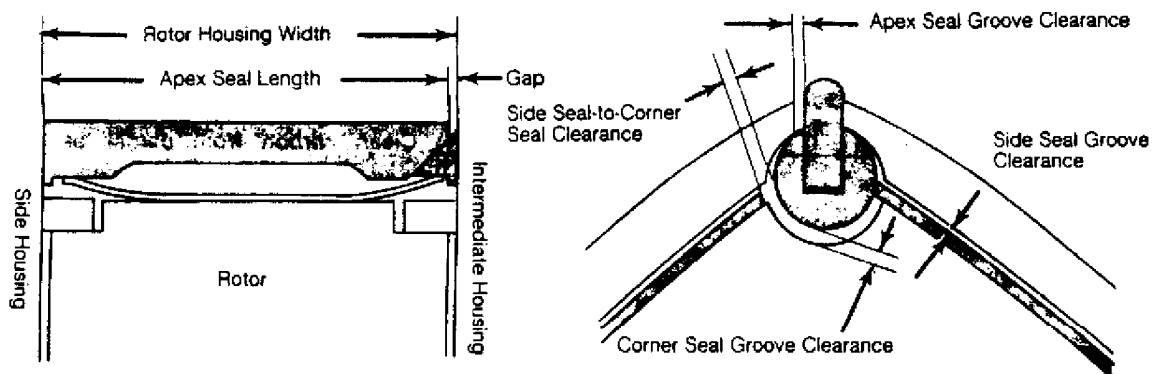
Fig. 18: Measuring Clearance of Apex, Side & Corner Seals

3) If neither end of gauge goes into groove, it indicates that gap conforms to specifications. If "Go" end of gauge goes into groove, it indicates that gap is more than standard, but less than wear limit. In this case replace corner seal. See Fig. 18.

4) If both ends of gauge (both the "Go" and "No Go" ends) fit in groove, it indicates that gap exceeds wear limit. Replace rotor.

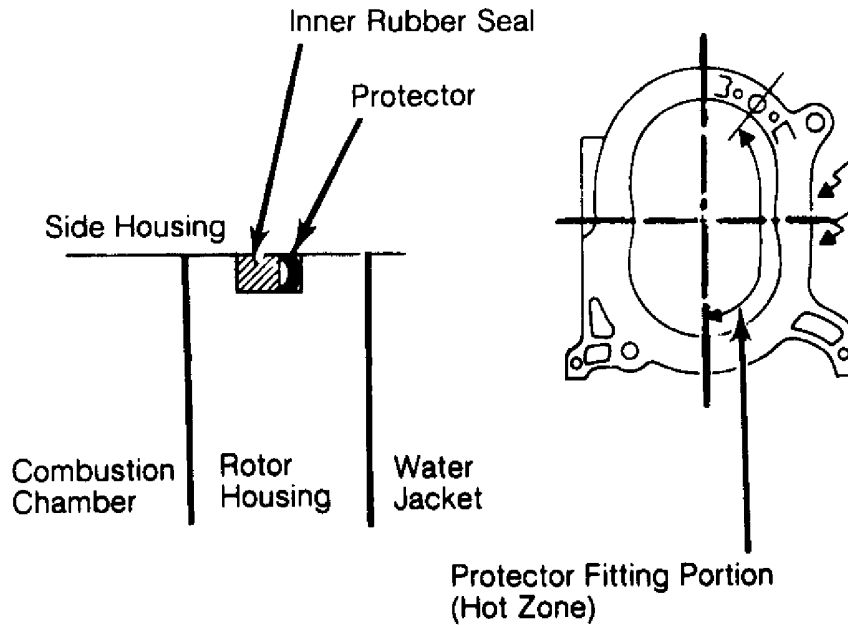
Fig. 23: Installing Protectors for Inner Sealing Rubbers
Apply light coat of petroleum jelly to hold seals in place.

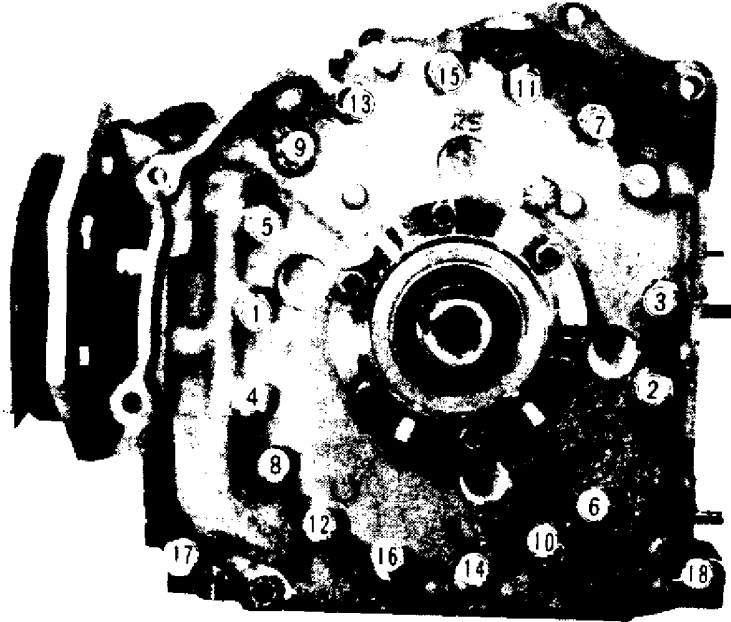
Fig. 26: Tightening Sequence of Tension Bolts
Replace all tension bolt sealing washers when the engine is overhauled.

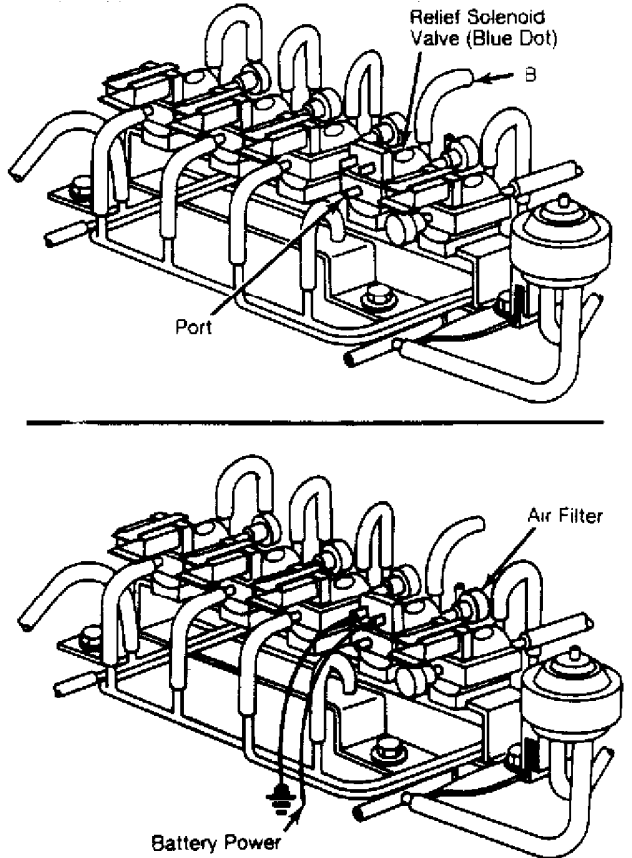
Fig. 3: Testing Relief Solenoid Valve

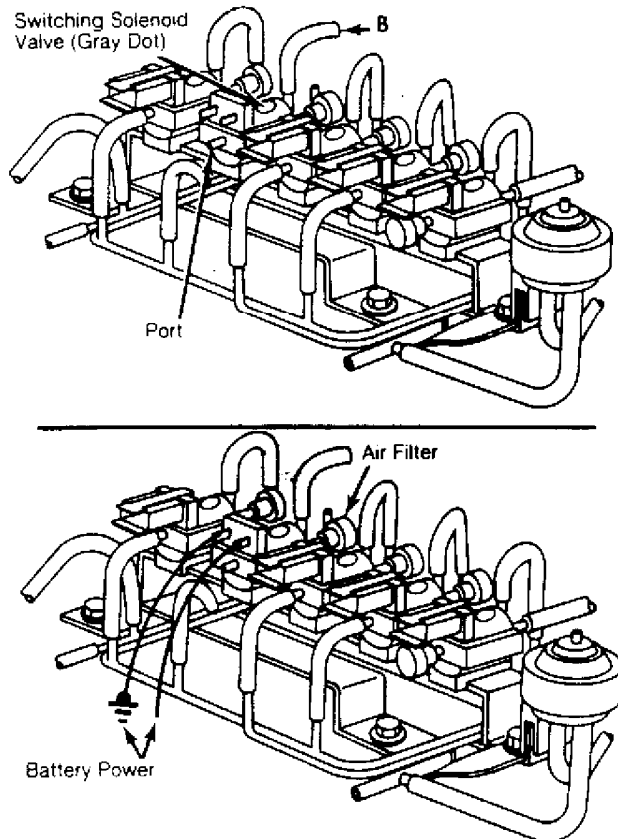
Fig. 5: Testing Switching Solenoid Valve

5) Slowly increase engine speed from idle. Voltmeter should read near 12V at any engine speed. Quickly accelerate engine; there should be NO current flow to switching valve. If switching valve does not respond as outlined, replace switching solenoid valve.

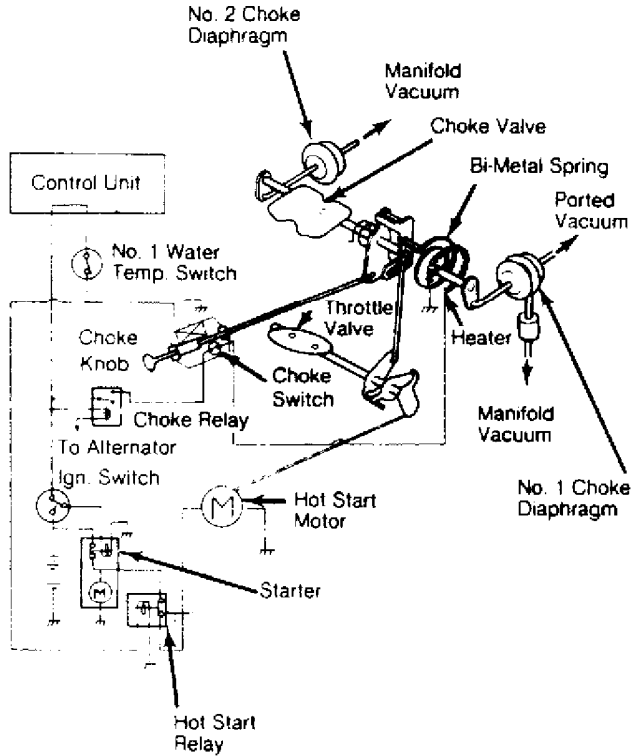
Fig. 1: Choke Return and Hot Start Assist Systems

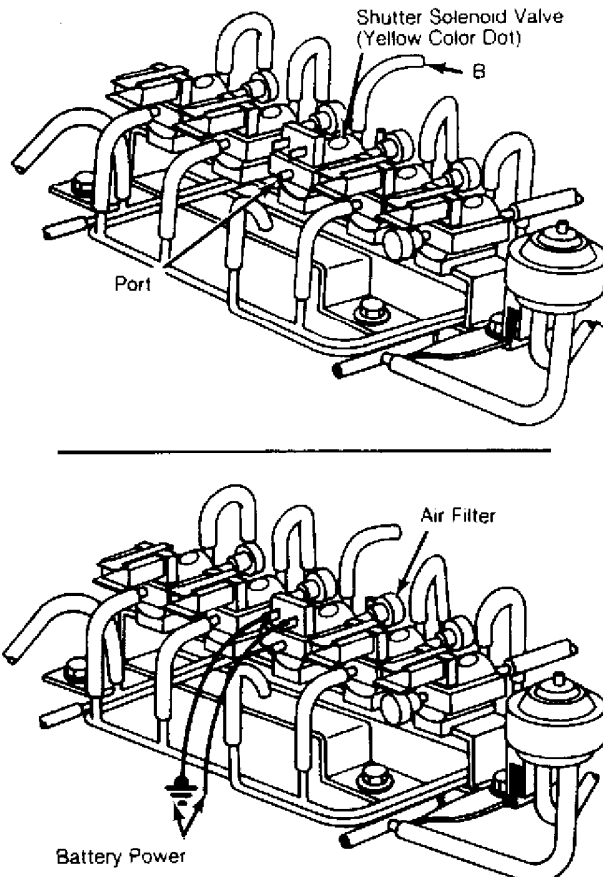
Fig. 3: Testing Shutter Solenoid Valve

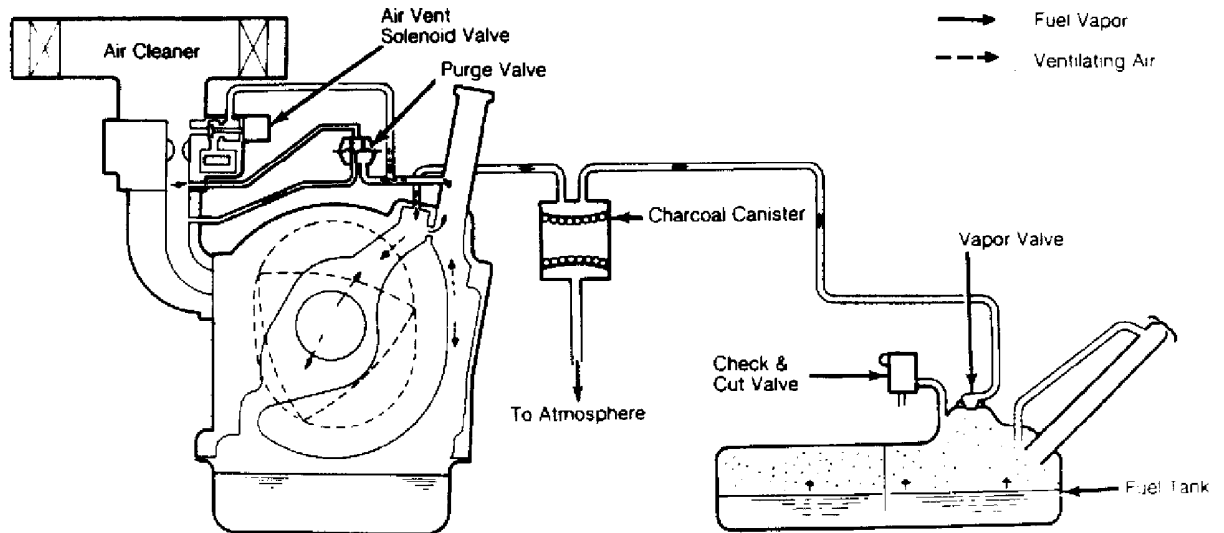
Fig. 2: Mazda RX7 Air Vent and Fuel Evaporation System

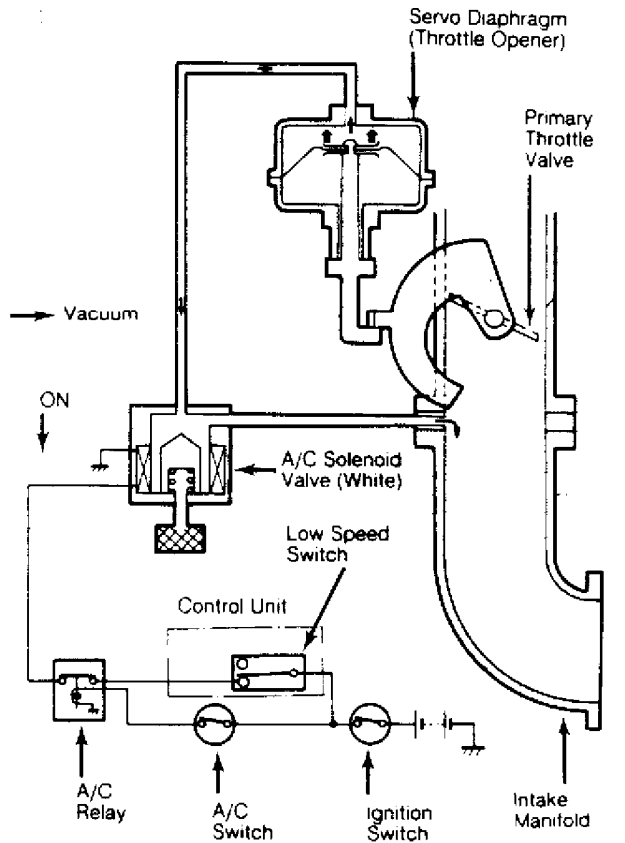
Fig. 3: Throttle Opener

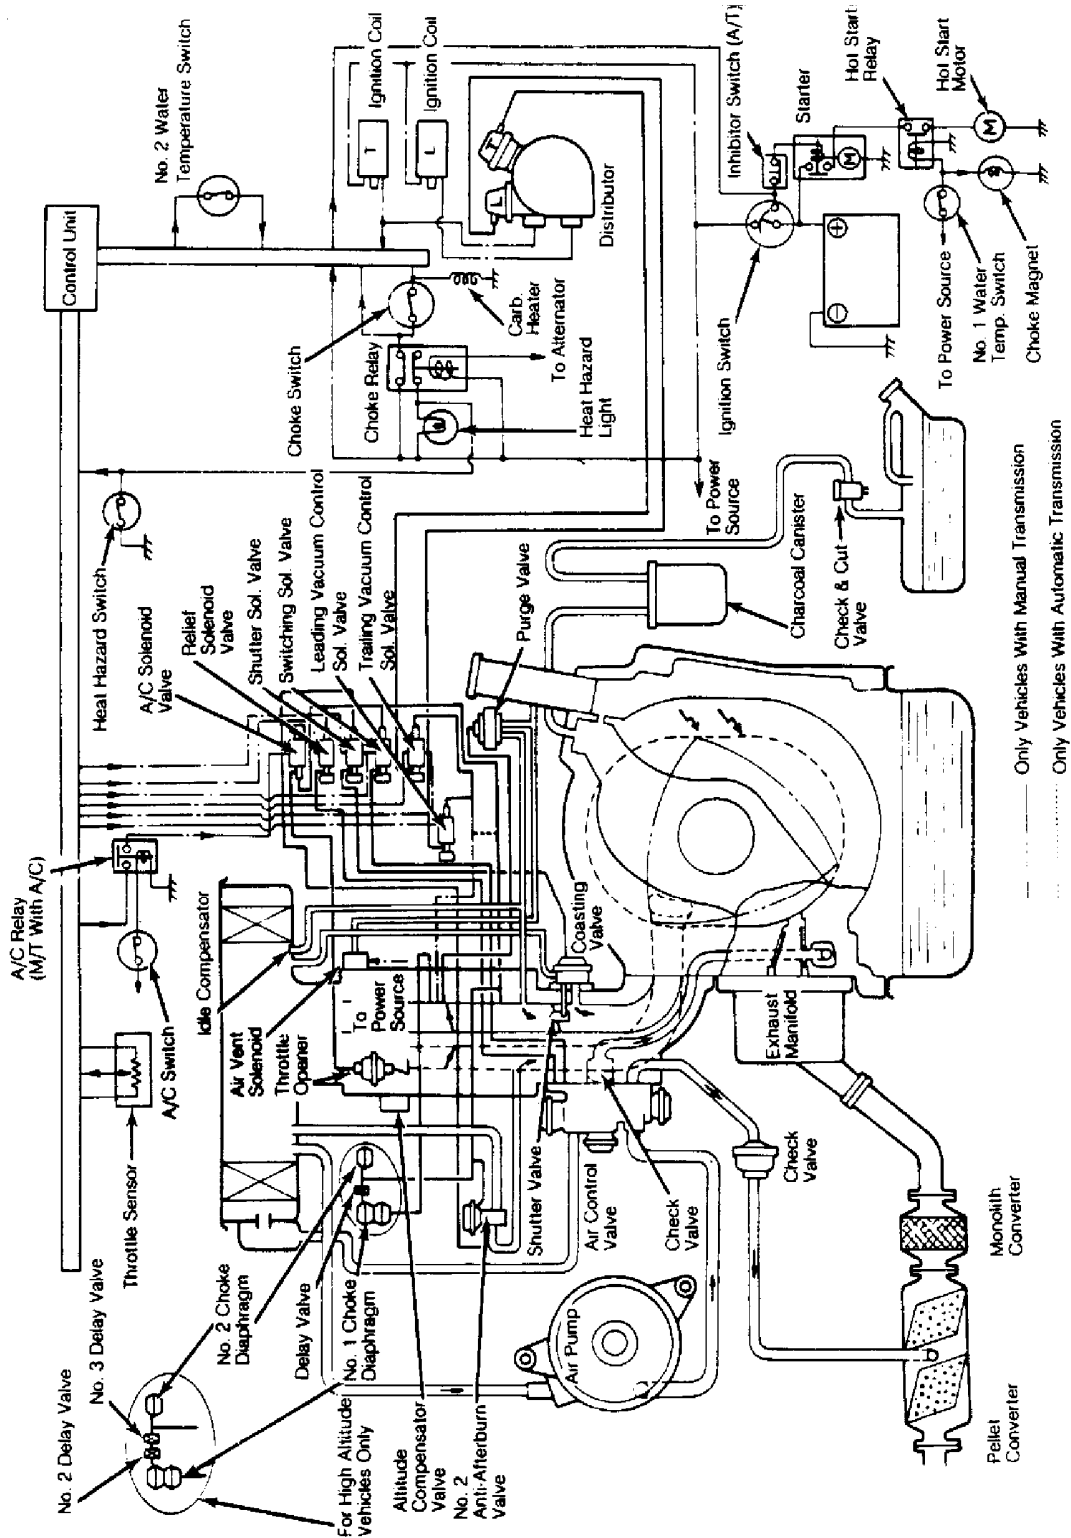
Fig. 1: Mazda RX7 Rotary Engine Vacuum Diagram

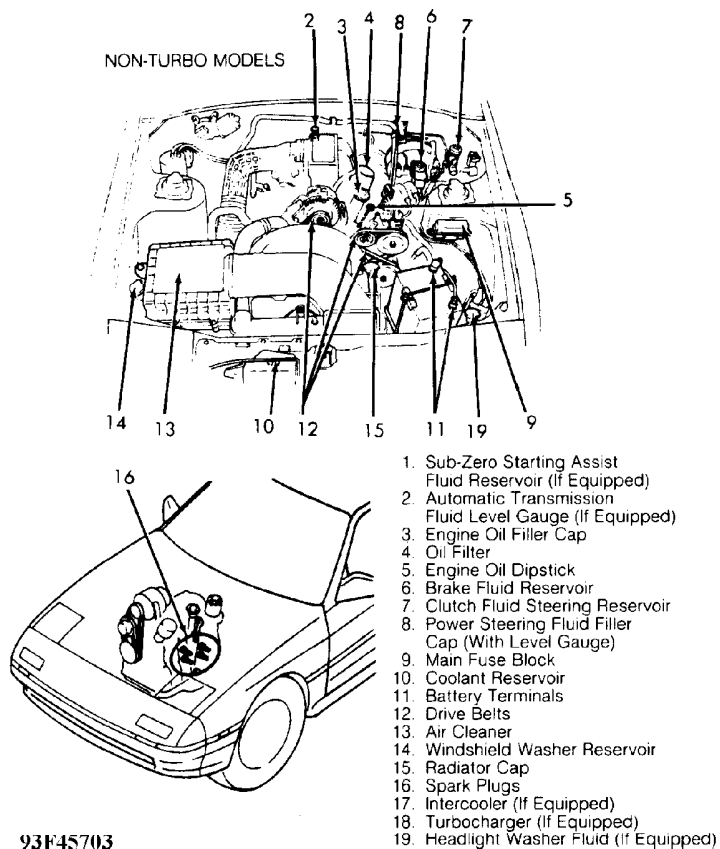
93F45703

Fig. 1: Service Point Locations (Typical Non-Turbo Engine)
Courtesy of Mazda Motor of America, Inc.

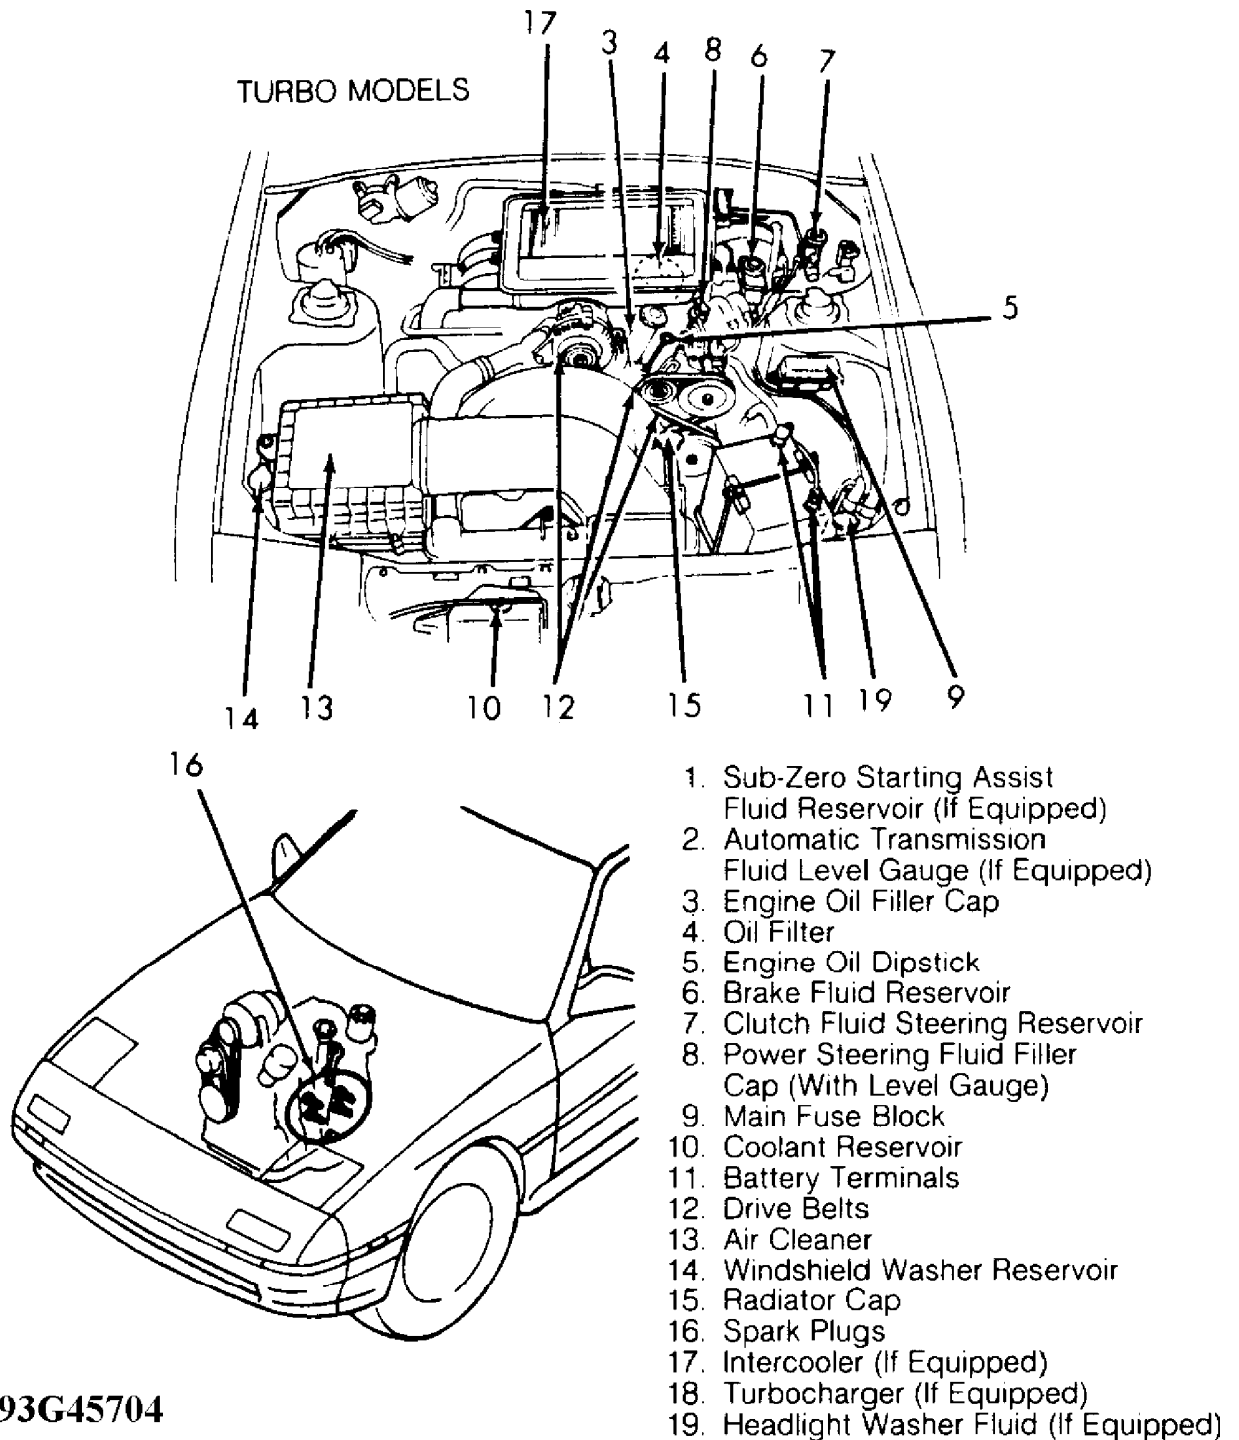
93G45704

Fig. 2: Service Point Locations (Typical Turbo Engine)
Courtesy of Mazda Motor of America, Inc.

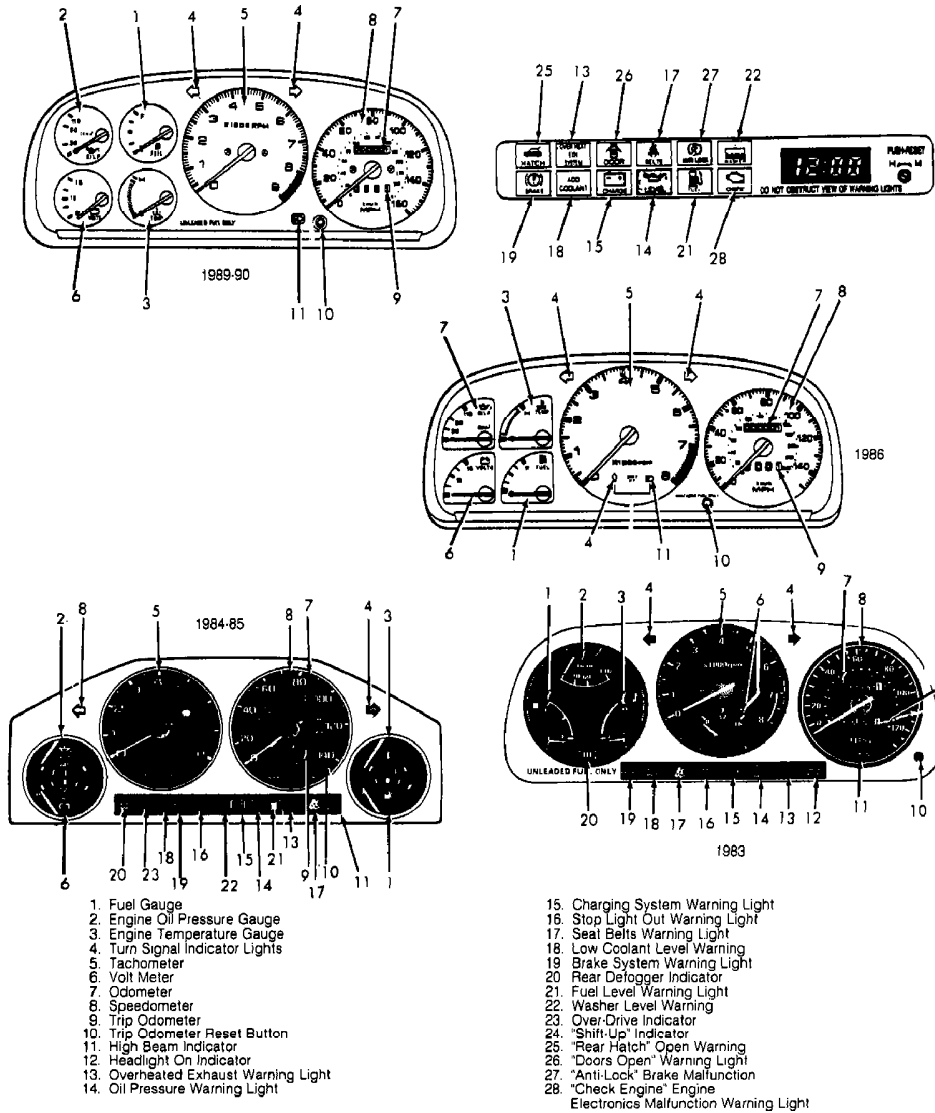
Fig. 1: Dash Gauges & Warning Lights
Courtesy of Mazda Motor of America Inc.

The warning lights will come on with the ignition. Any warning light which does not come with the ignition must be checked and repaired.

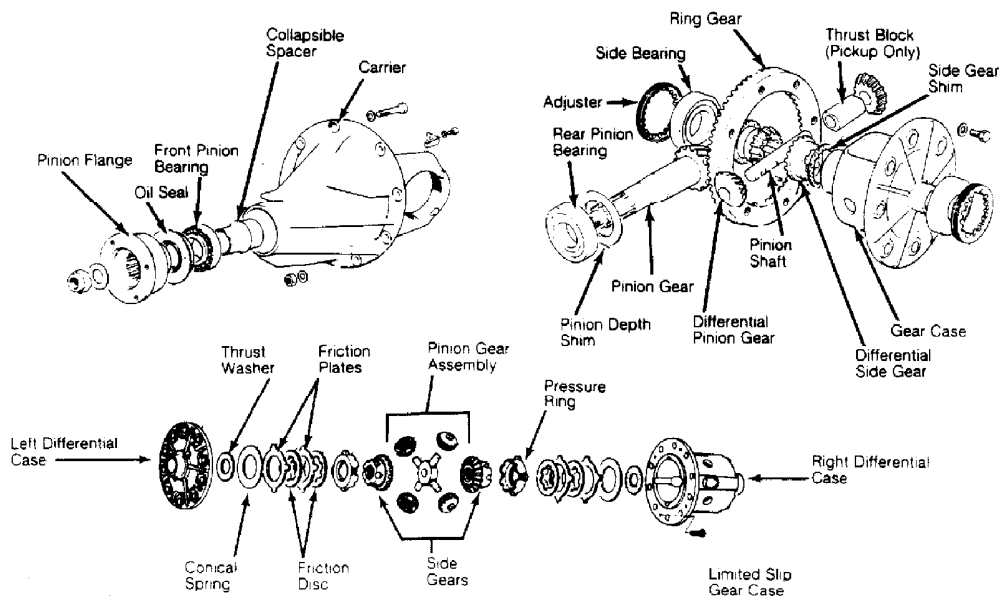
Fig. 1: Exploded View of Mazda Rear Axle Assembly

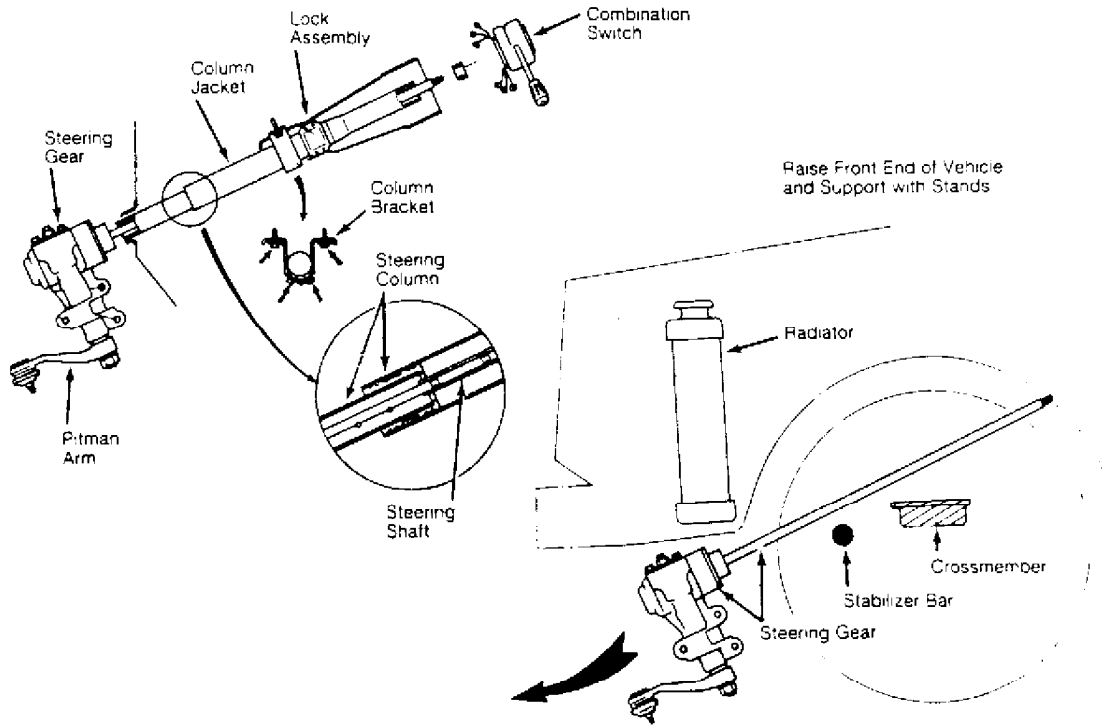
Fig. 1: GLC Wagon Steering Column  
RX7 steering column is similar.

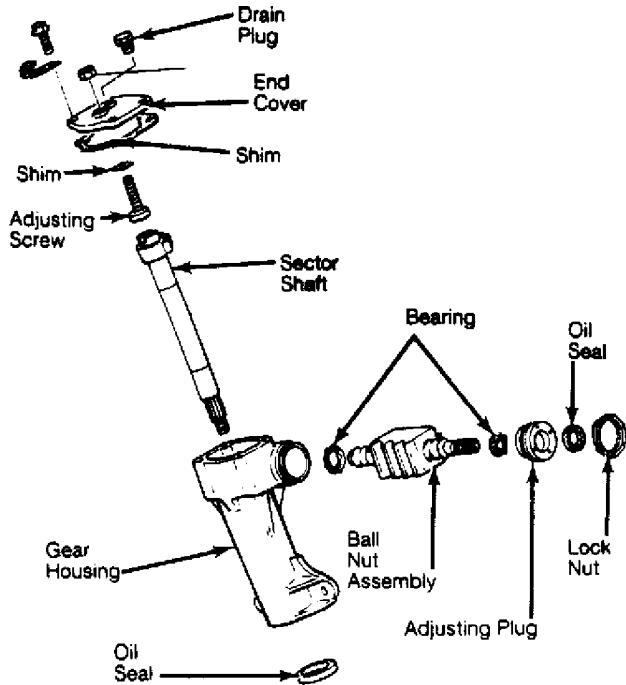
Fig. 1: Exploded View of Steering Gear Assembly (Pickups)

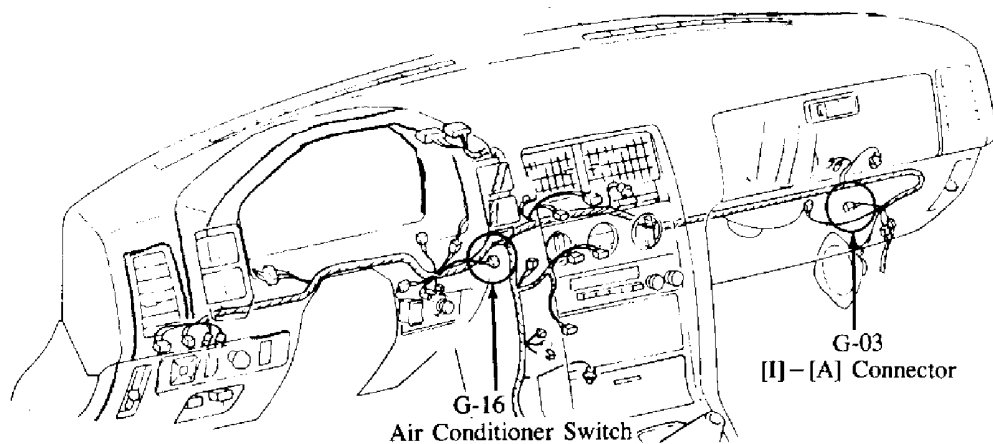
Fig. 1: A/C Indicator Light Harness Routing

Some air conditioner kits manufactured by Lone Star Manufacturing Company may contain incorrectly assembled harness connectors. If the indicator light on the air conditioner switch does not illuminate, or illuminates dimly after installation, the problem may be due to incorrectly assembled G-03 or G-16 connectors. See Fig. 1.

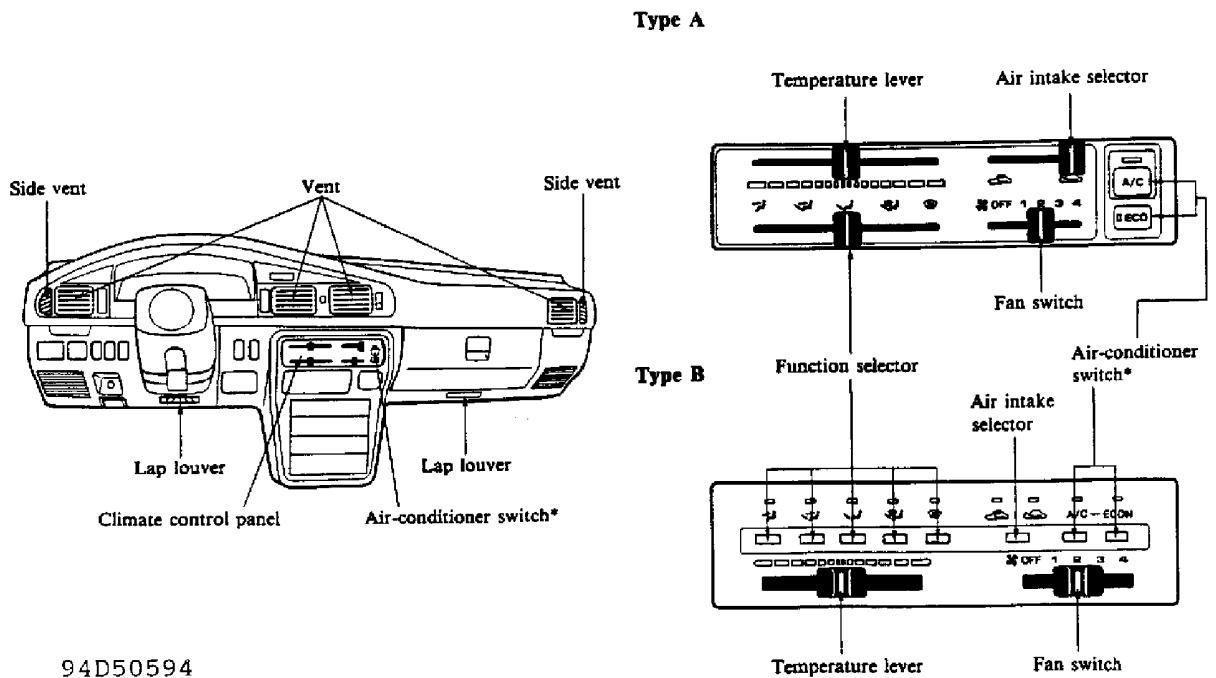
94D50594

Fig. 8: Climate Control System Layout

Shown in Fig. 8 is a typical climate control system. Detailed descriptions of each function are found under the heading "Driving Your Mazda" in the appropriate Owners Manual.

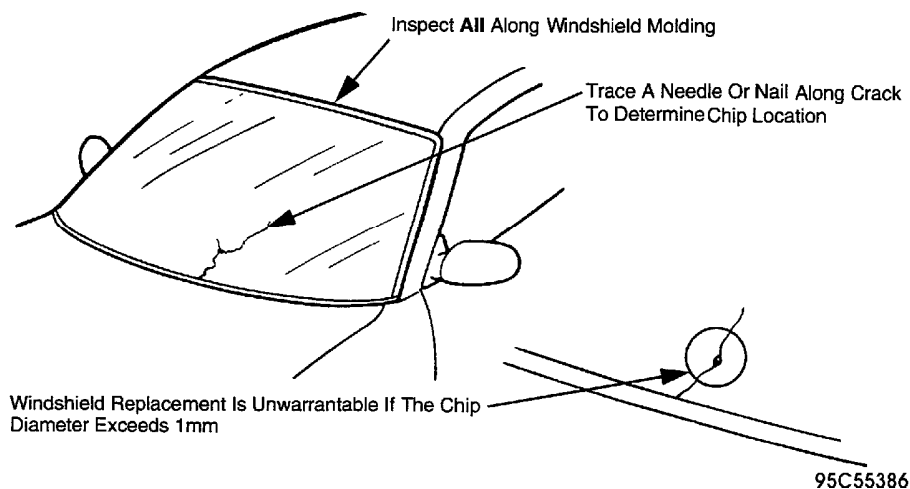
Fig. 1: Windshield Inspection

Windshield replacement is not warrantable if a chip larger than 1 mm in diameter exists along the length of the crack.

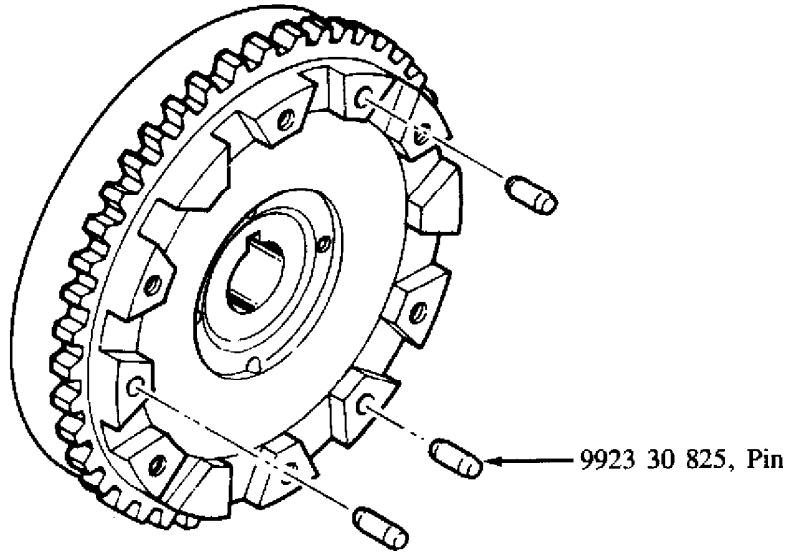
Fig. 1: 83-86 RX7 Flywheel and Alignment Pins

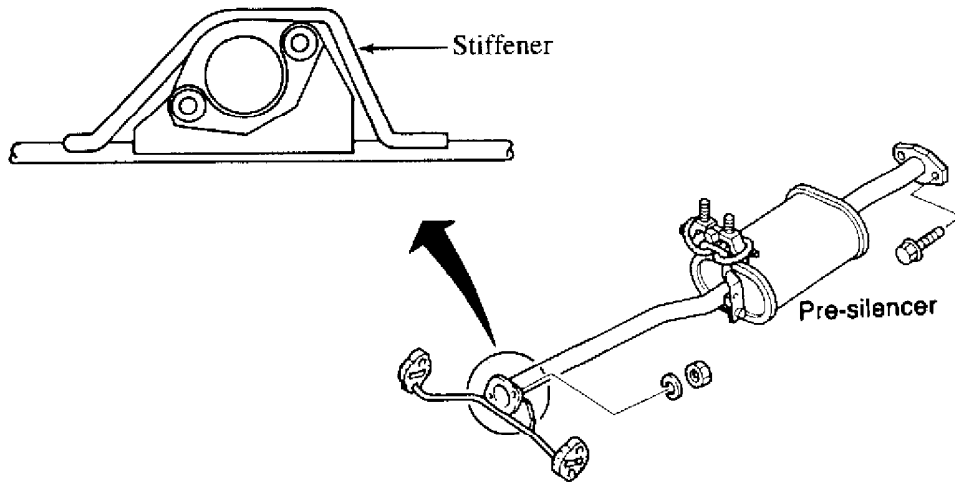
Fig. 1: View of Pre-Silencer with Stiffener

Check the exhaust hanger for breakage. If it is broken, replace the pre-silencer with the modified one which has been reinforced with stiffener as shown in Fig. 1.

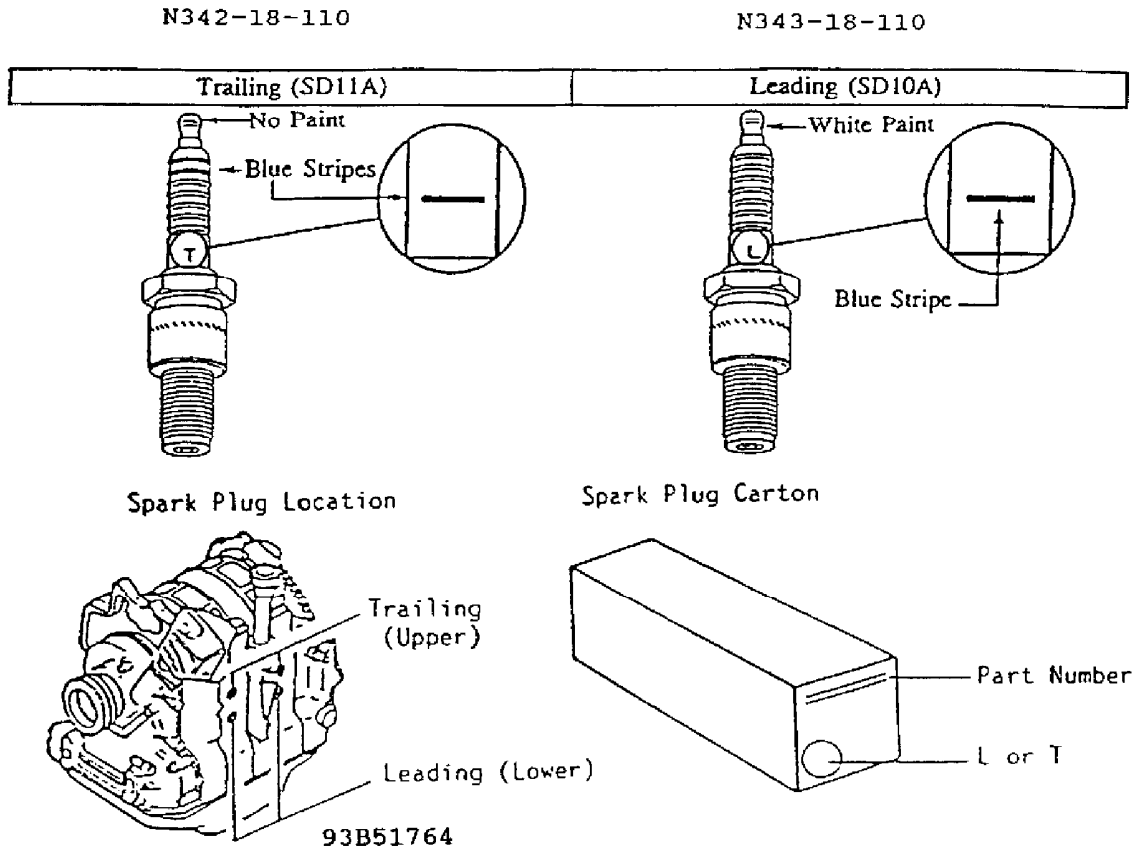
Fig. 1: Spark Plug Identification for 1986-91 RX-7 Engines

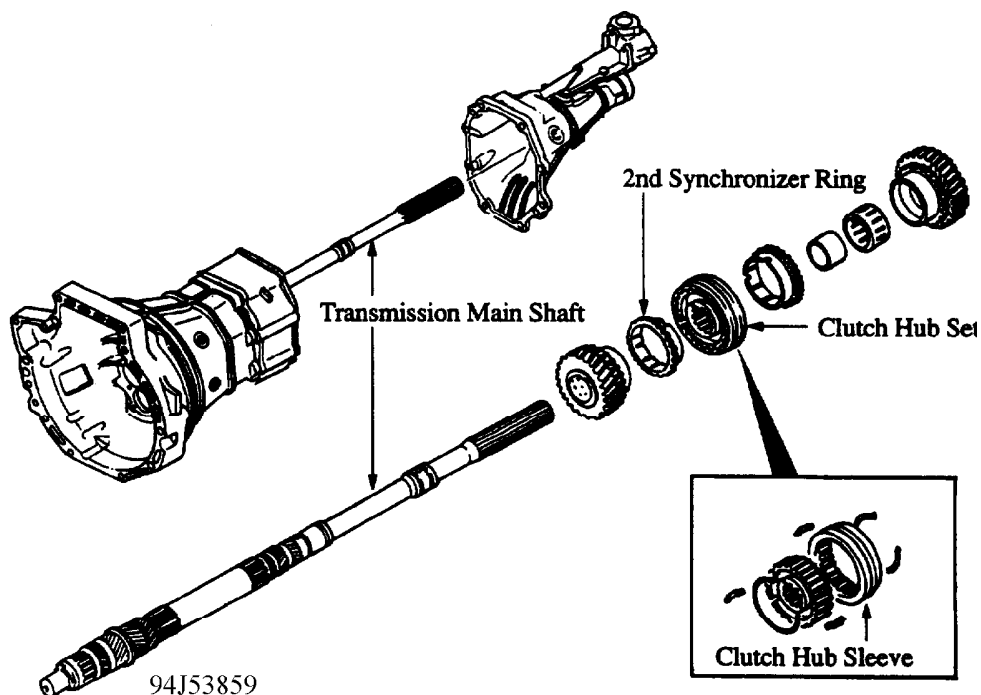
Fig. 1: 2nd Gear Synchronizer Ring and Assembly

If you experience hard shifting into 2nd gear after a cold start with an RX-7 (non-turbo) or Miata produced prior to April 1, 1991, replace the 2nd gear synchronizer ring and 1-2 clutch sleeve (or 1-2 clutch hub set) with redesigned ones. Refer to the appropriate service information for installation procedures.

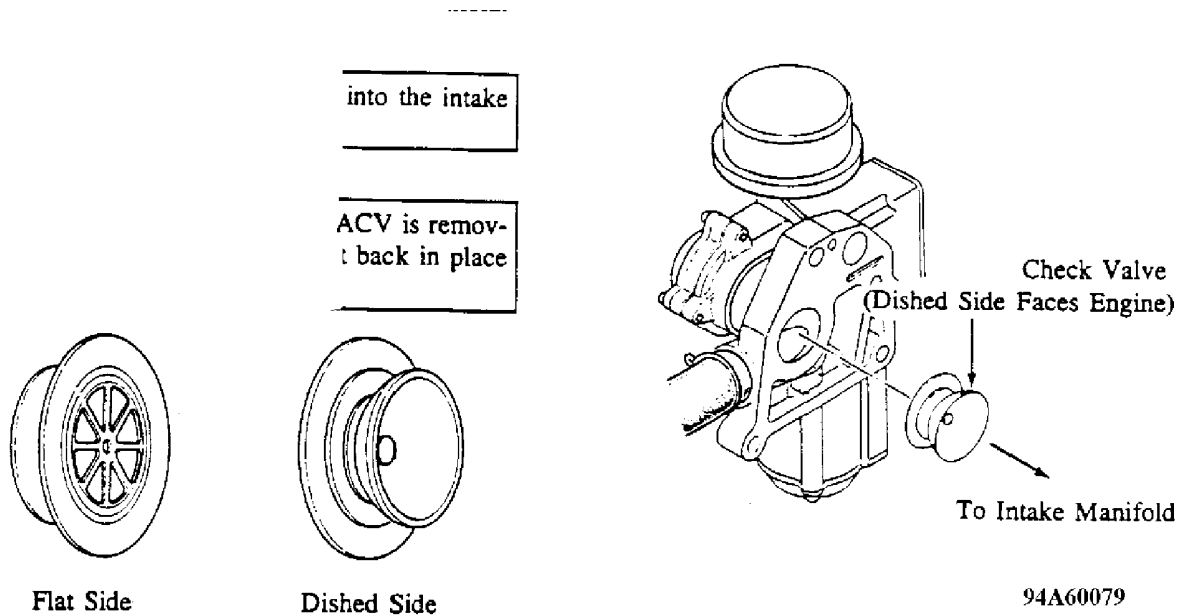
Fig. 13: Check Valve Position and Orientation

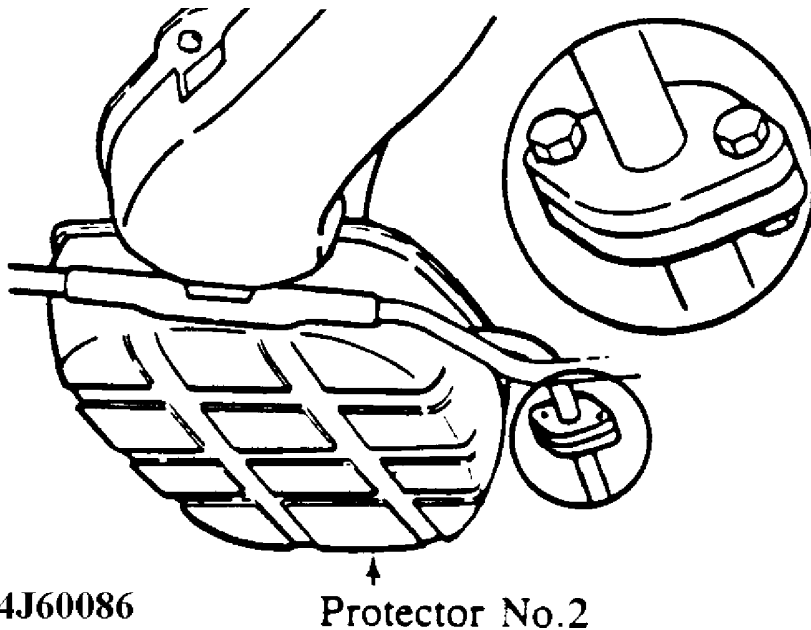
Fig. 20: Location of Protector No. 2

1. Lift the vehicle on a hoist.
2. Disconnect the split air pipe from the pellet converter.
3. Remove the catalytic converter lower cover (protector No. 2). See Fig. 20.
