CRUISE CONTROL SYSTEM

1983 Mazda RX7

1983 CRUISE CONTROL SYSTEMS

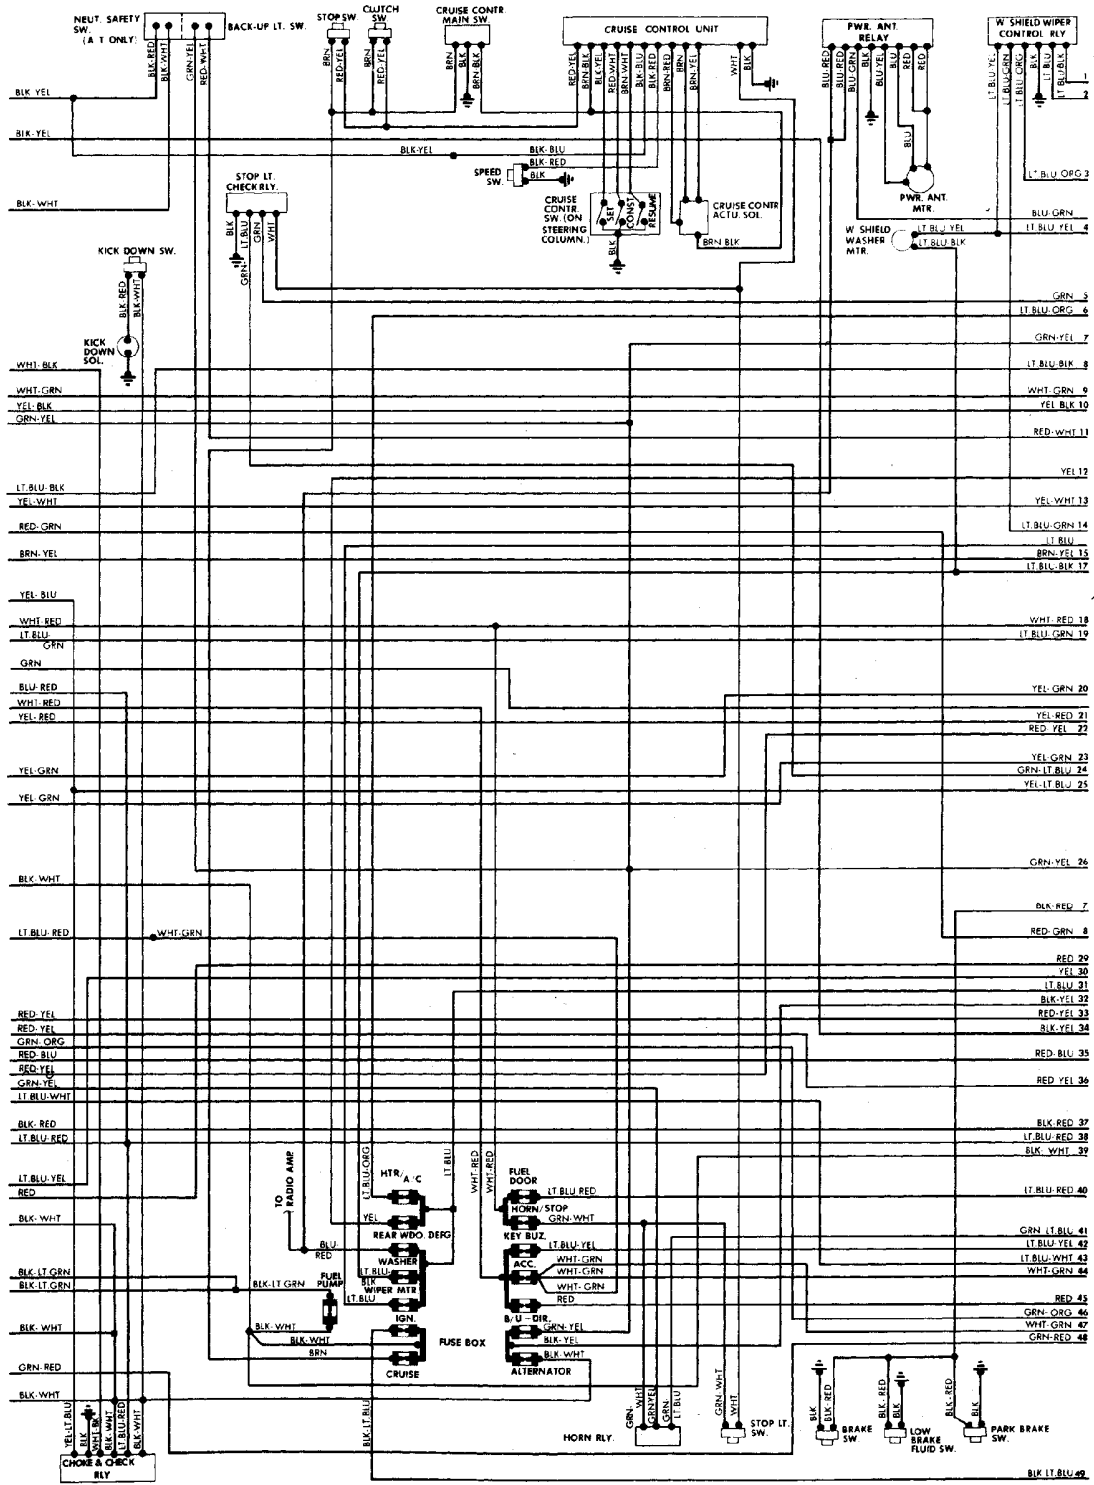
96120  
 Fig. 2: Fuse Block & Underdash
