Technical Bulletin

Mazda RX8 – Expansion Tank Coolant Level

Applicable References: ADM59860

Applications: Mazda RX8

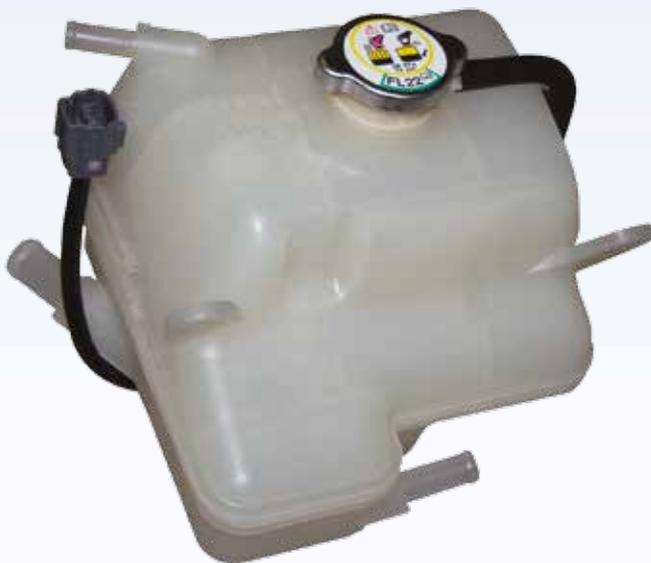
Note: Care is required when removing the coolant hose shown in the picture below, in order to avoid damage to the outlet on the radiator.
